Agencies Mobilize after Crude Oil Train Derails

A Response to the Galena, Illinois Bakken Incident

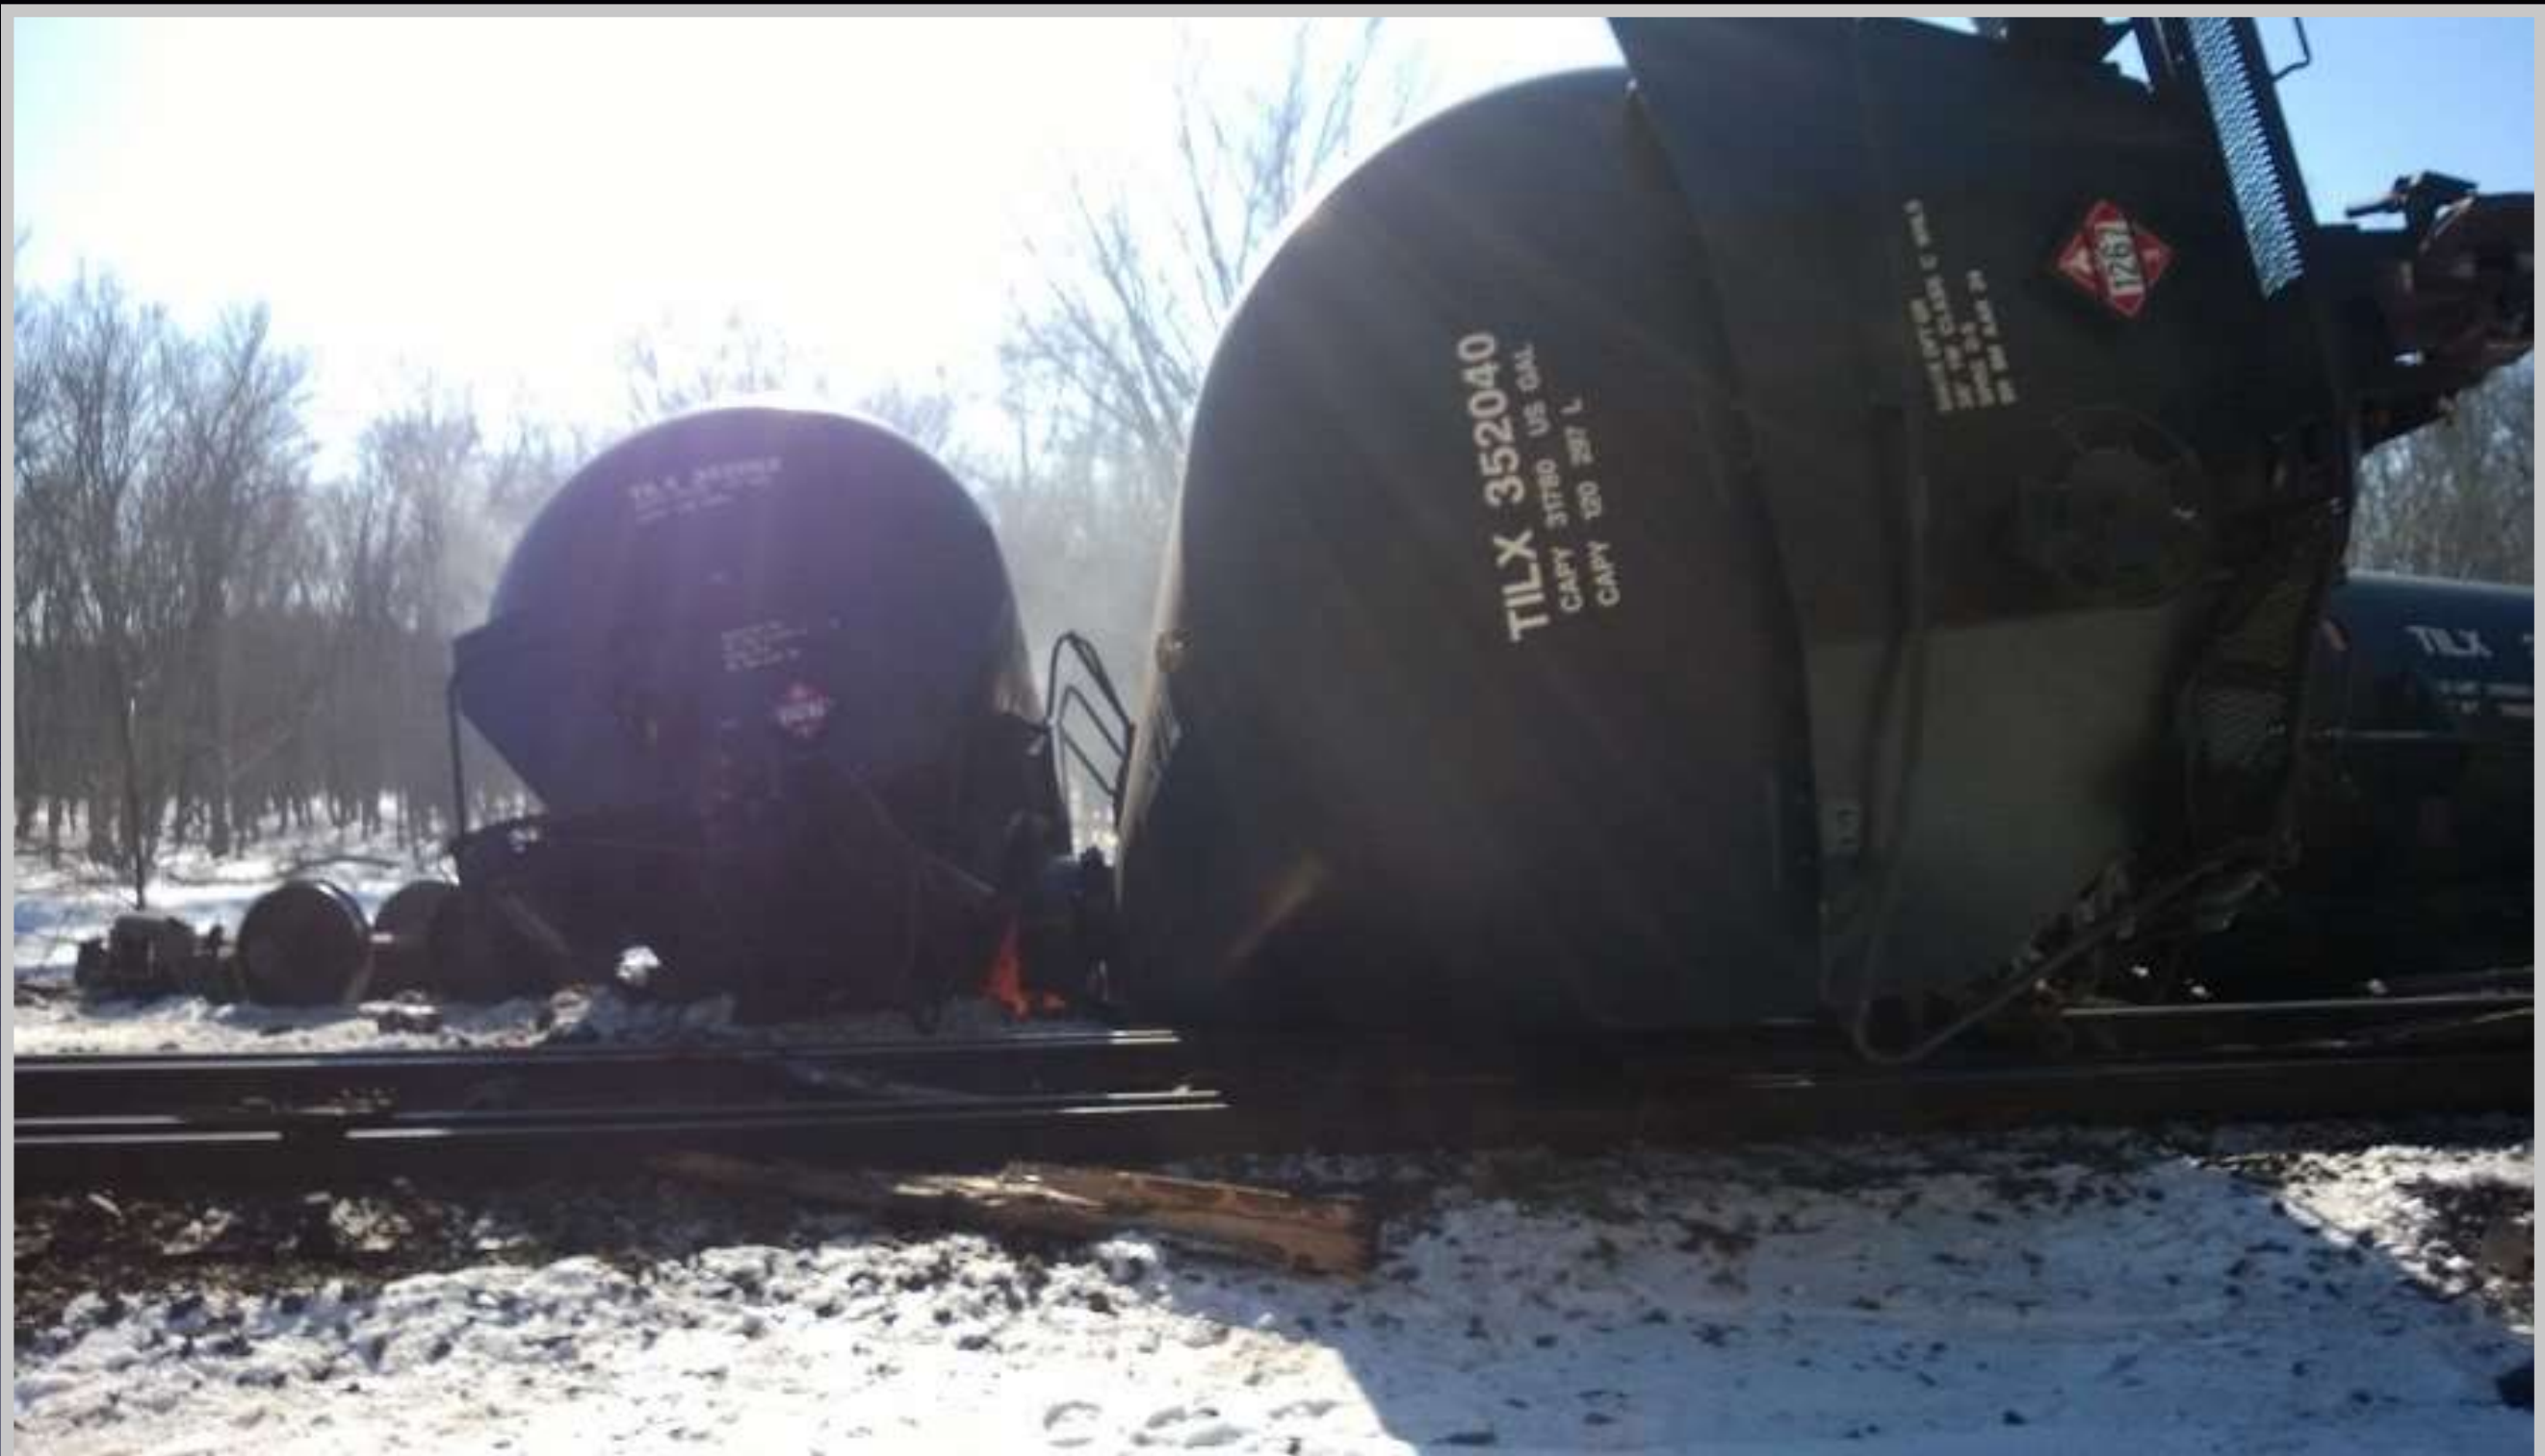
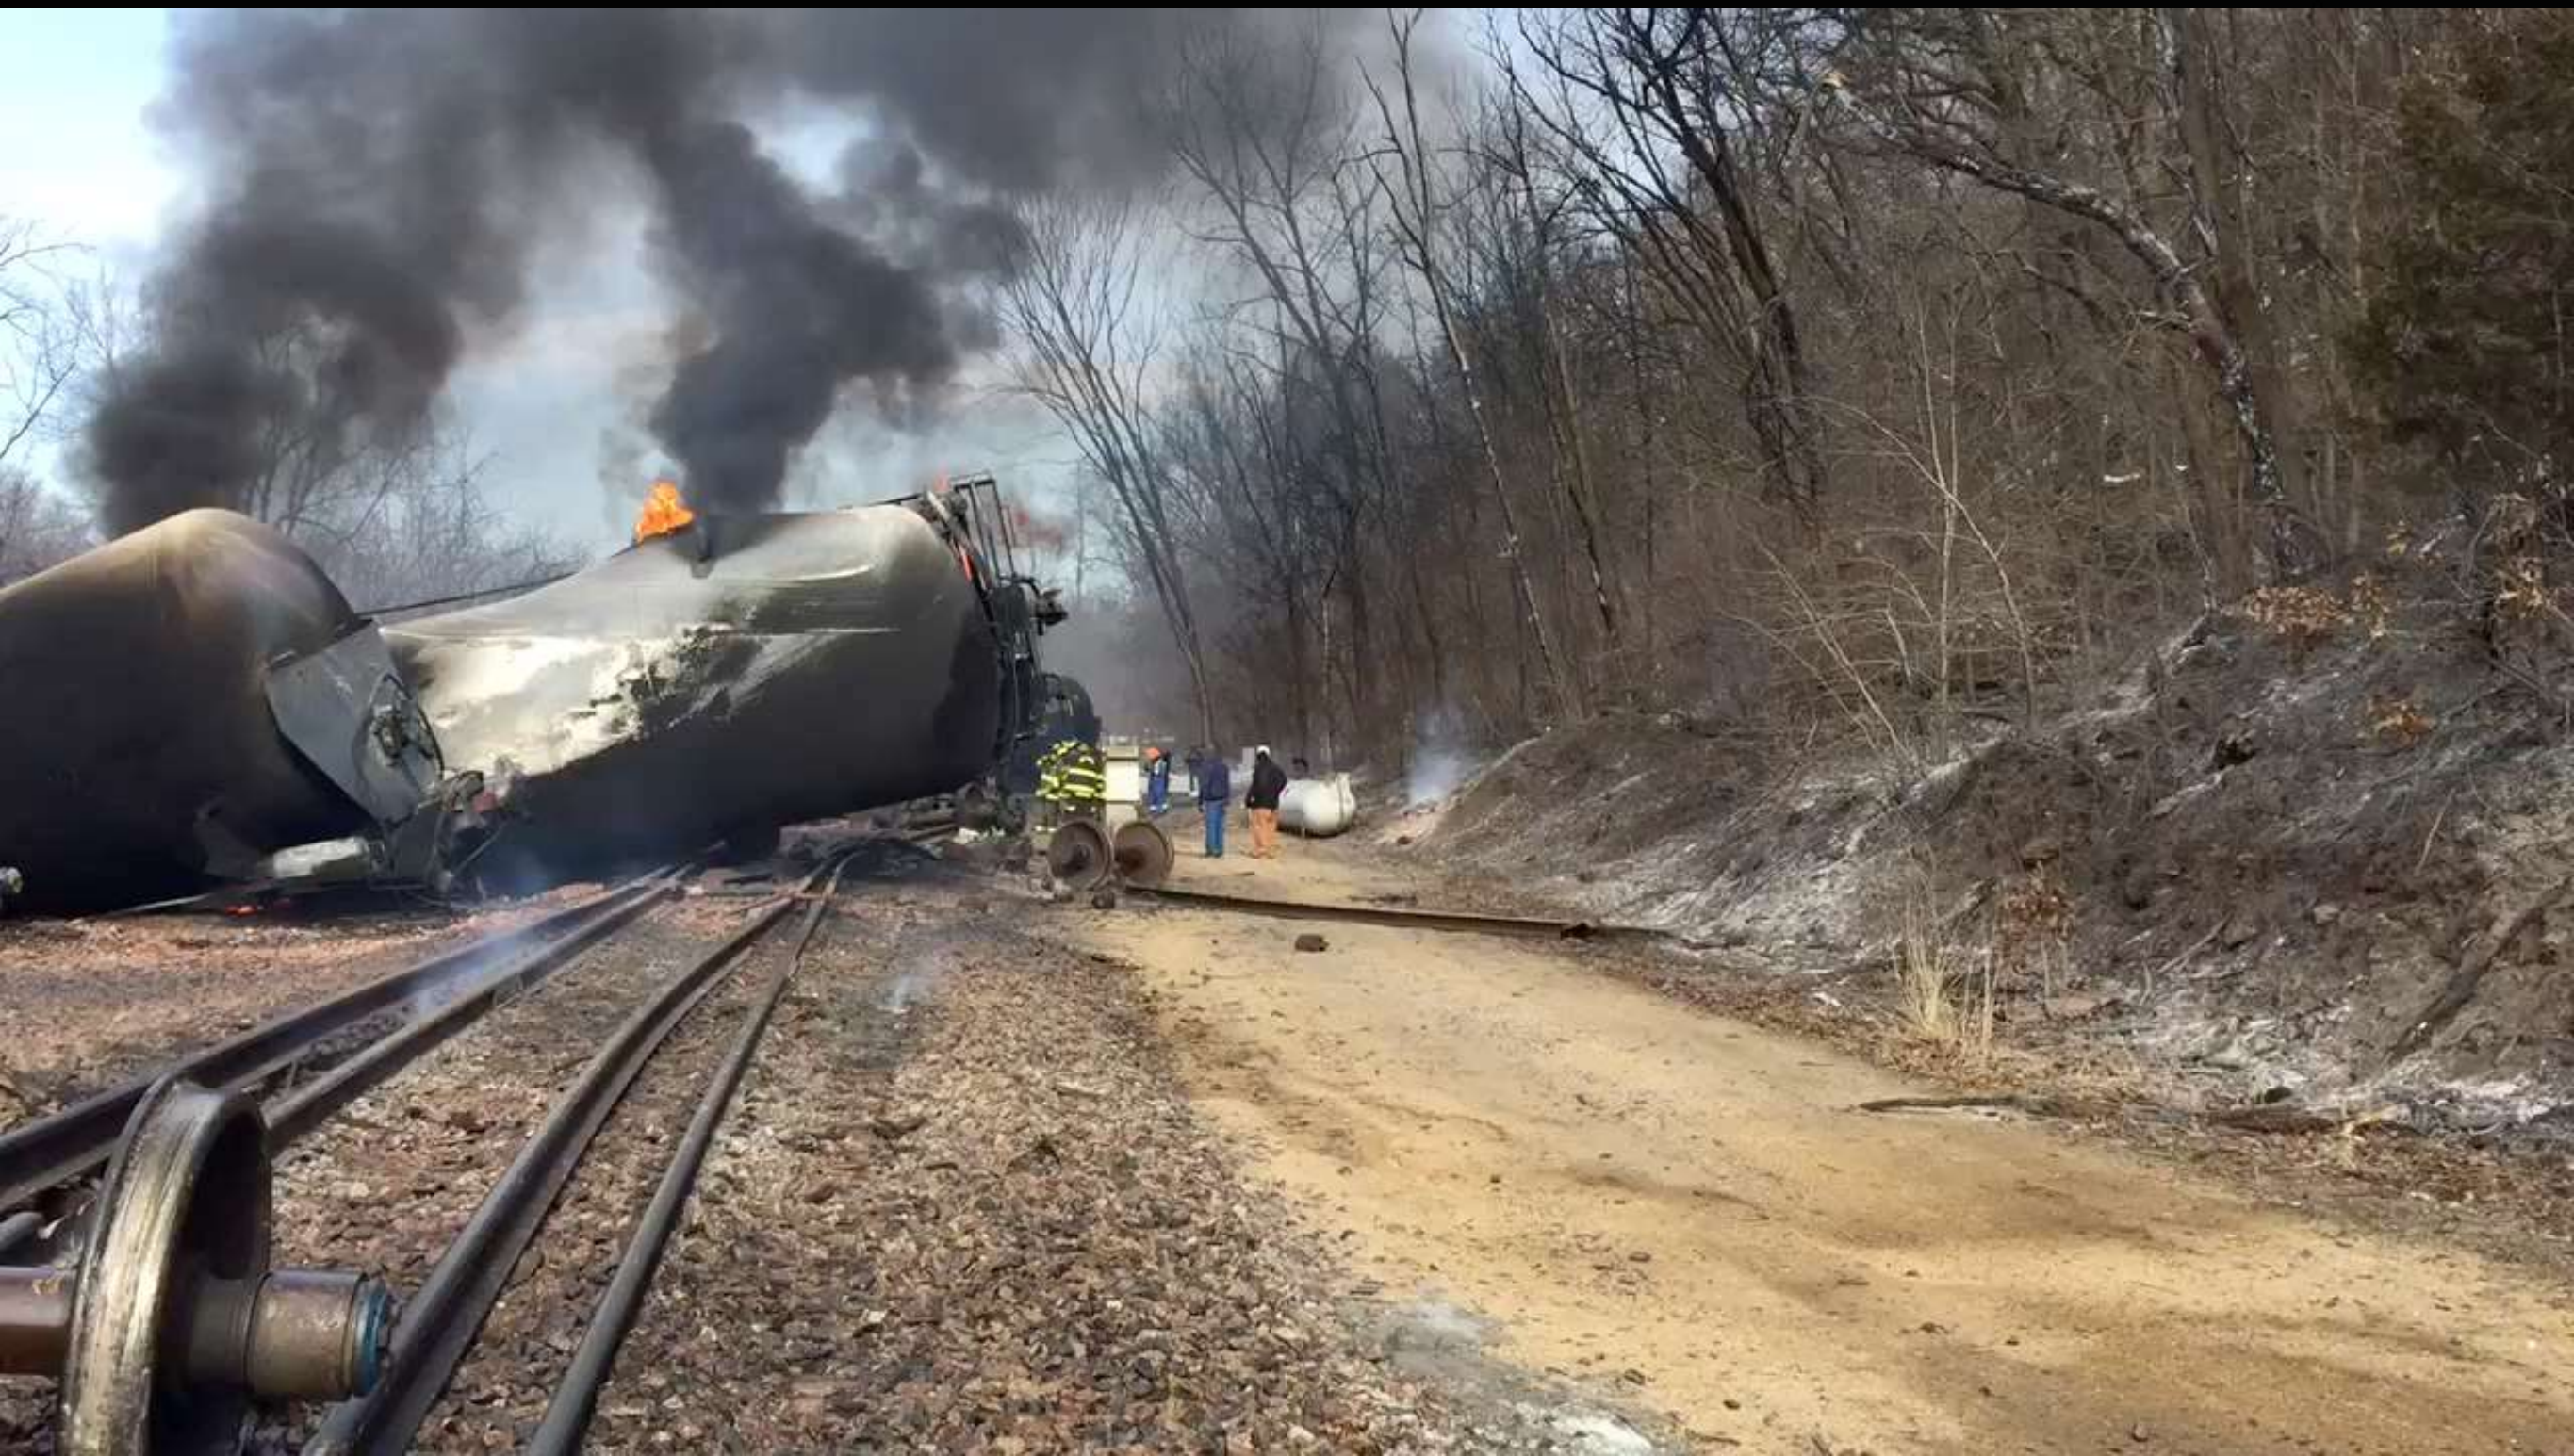
Initial Fire

- 15:02 Light smoke a visible flame.
- 15:26 Pulled personnel back
- 17:08 Large explosion like failure
