Agencies Mobilize after Crude Oil Train Derails

A Response to the Galena, Illinois Bakken Incident

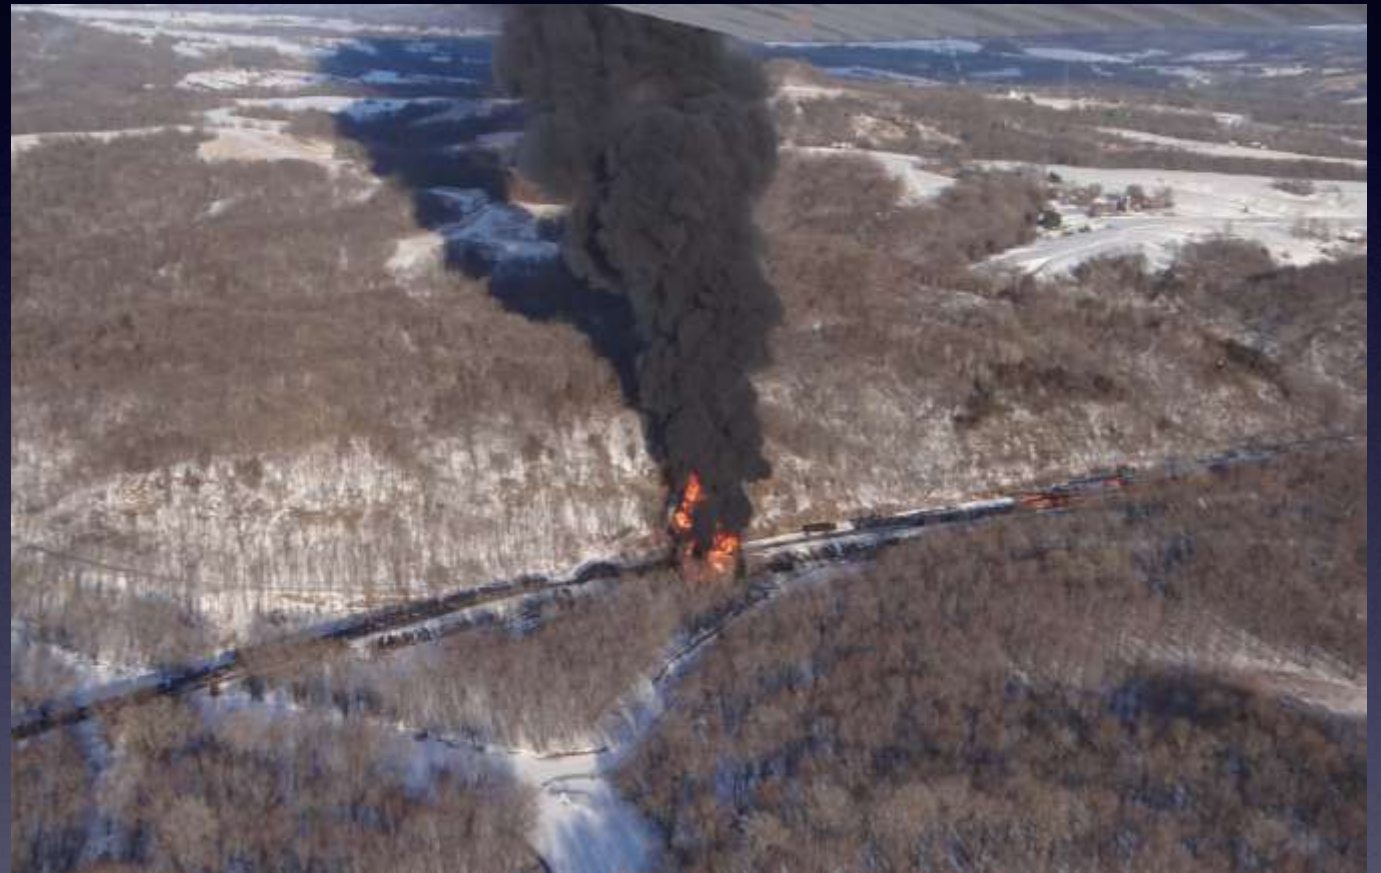
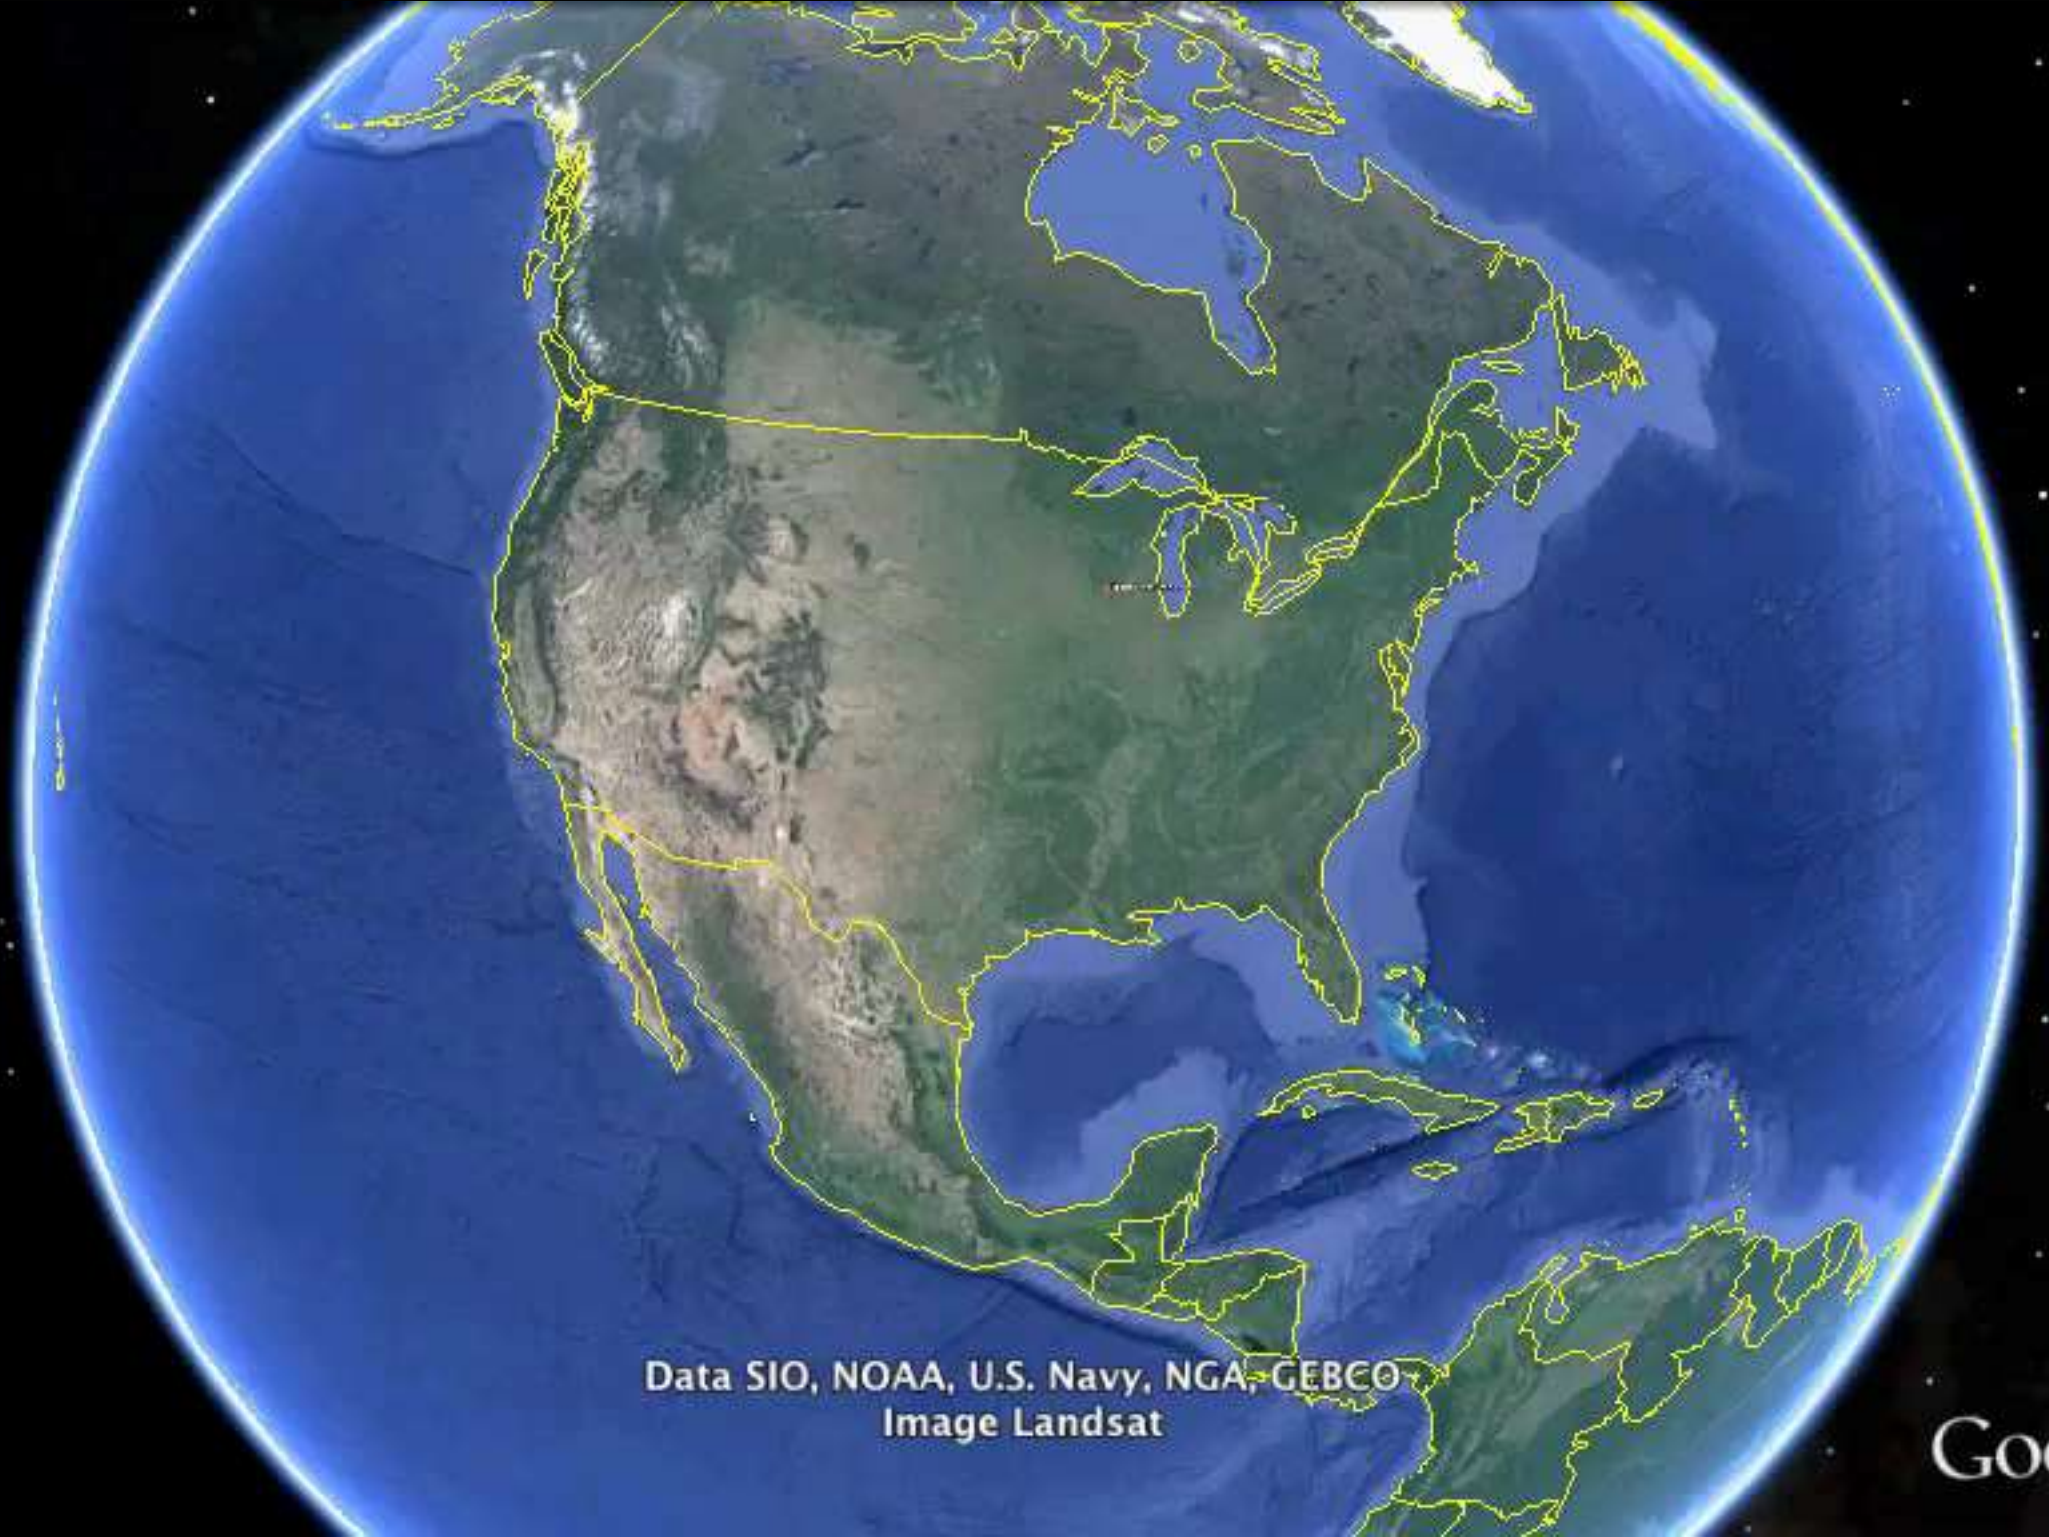
21 tank cars of a 105 car BNSF train derailed at milepost 171.6 of the Aurora Sub near Galena, Illinois. Each of the cars was carrying around 30,000 gallons crude oil.

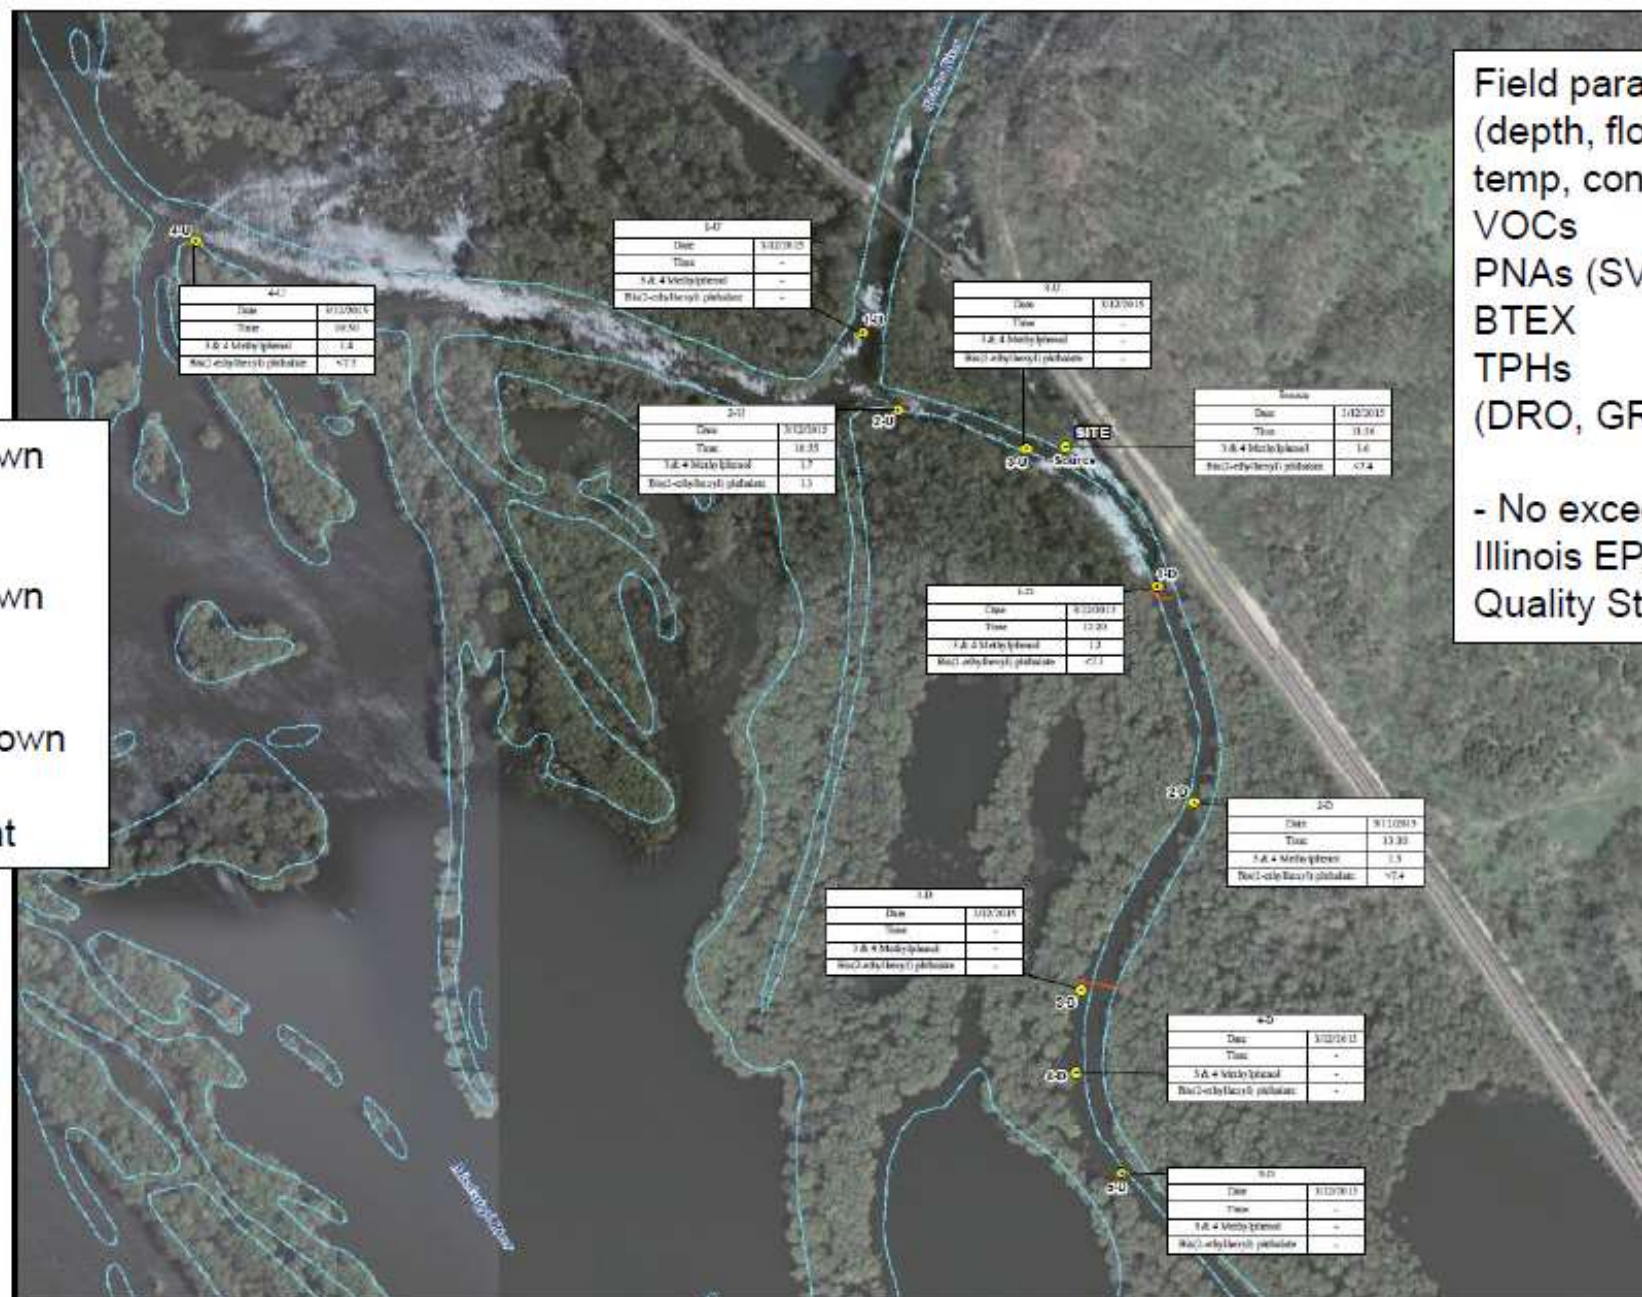
- No exceedances of
Illinois EPA Surface Water
Quality Standards

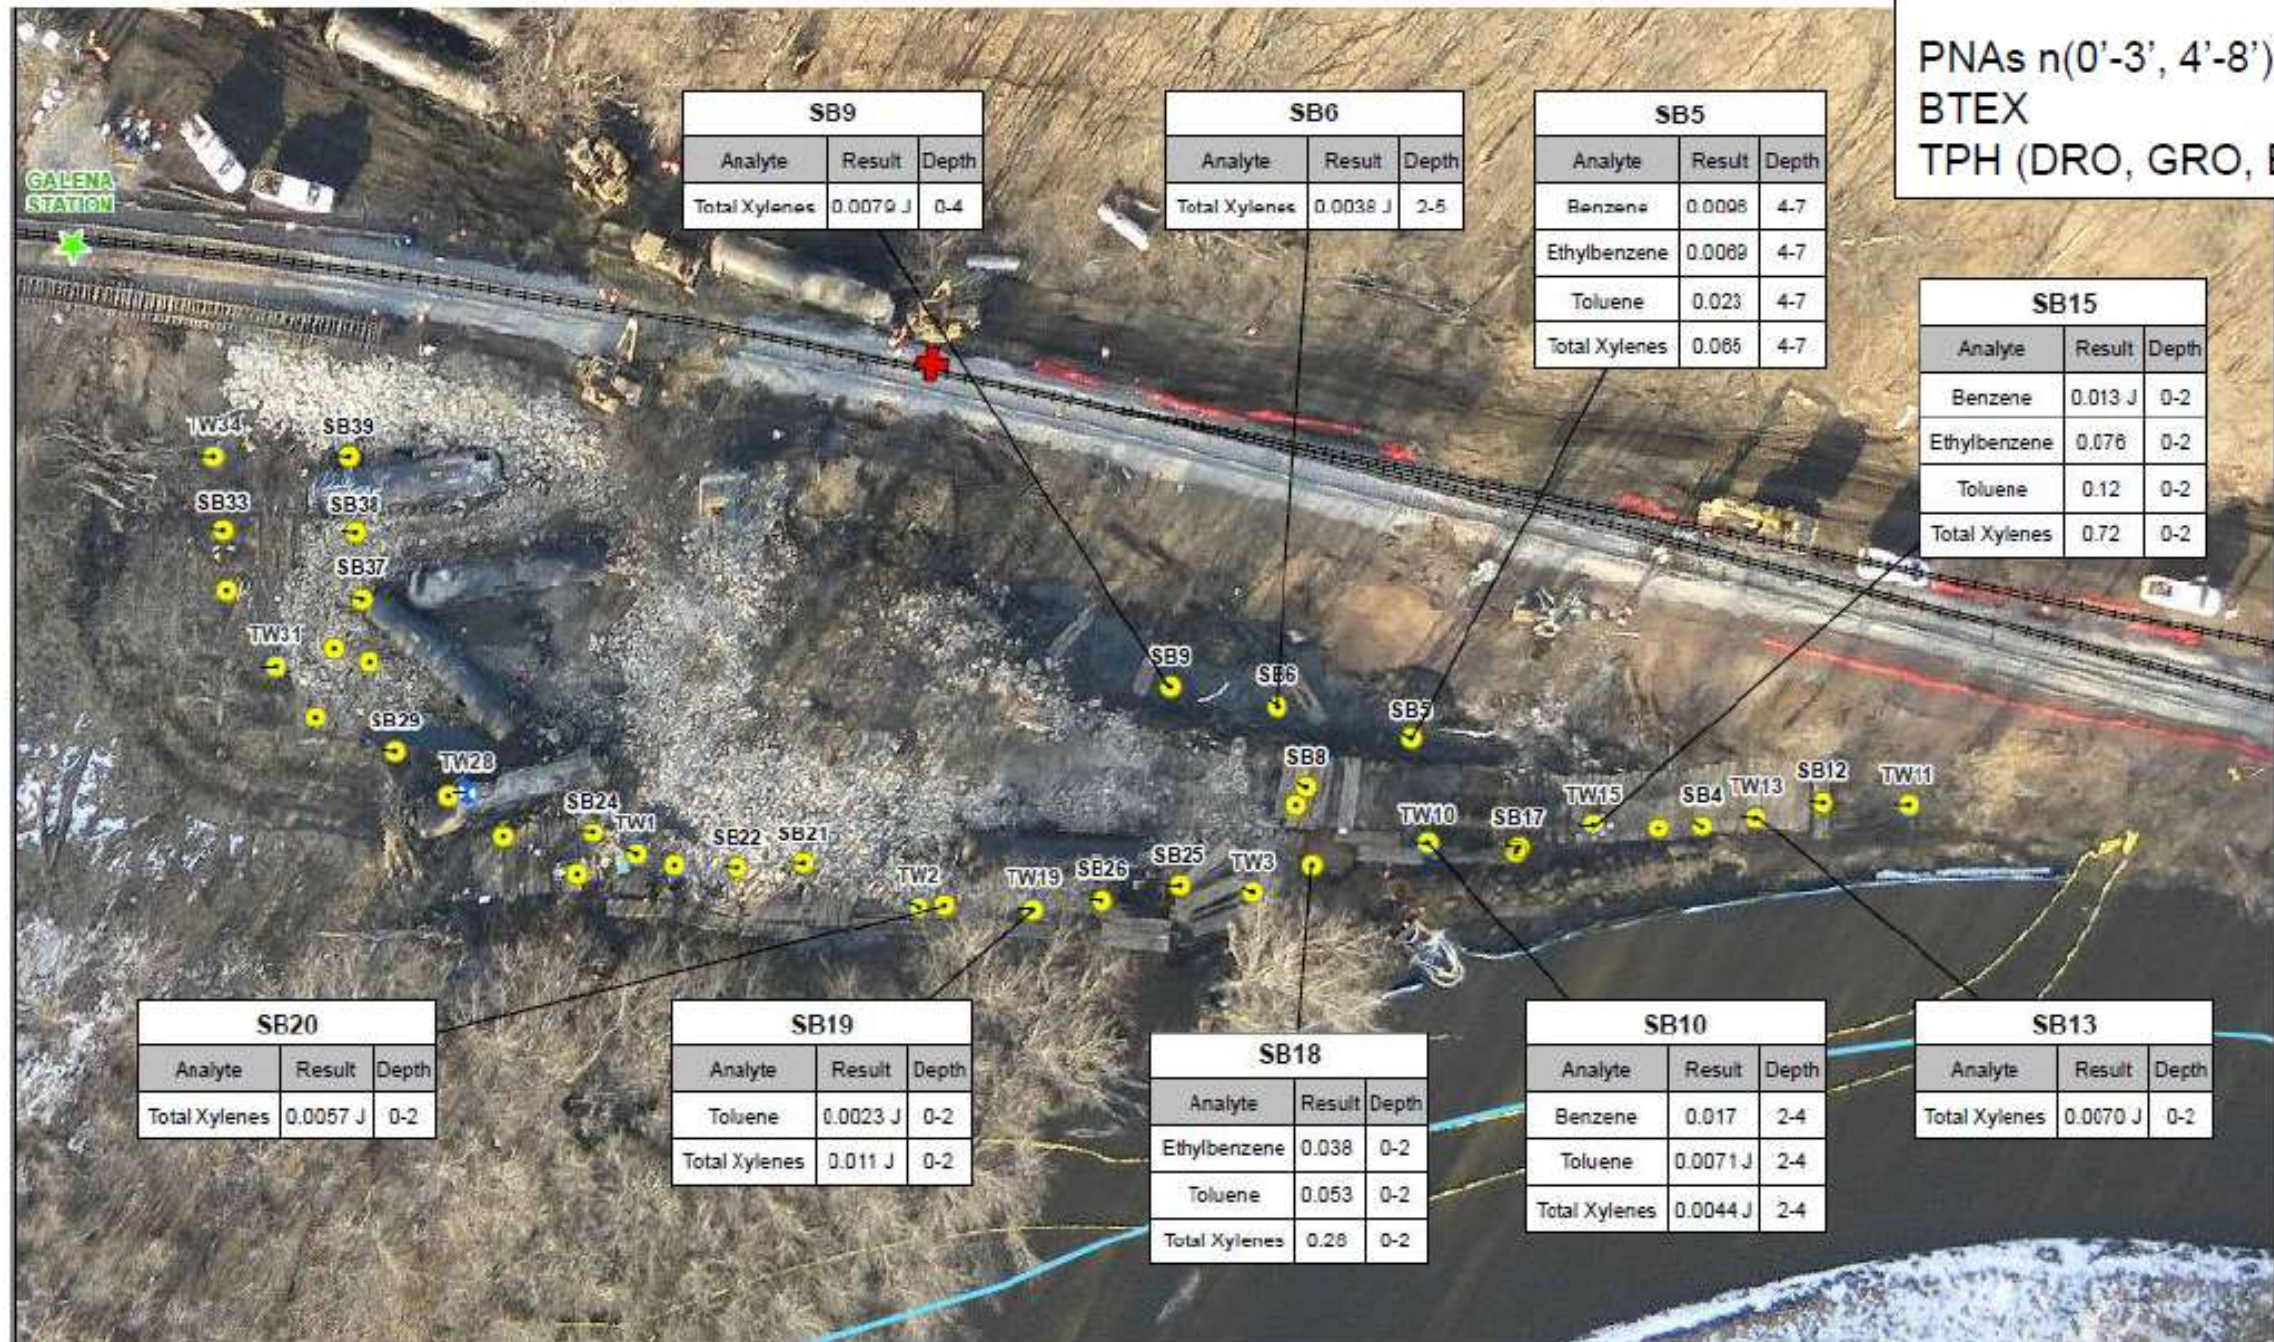
Soils

- 143 samples from 35 borings screened
39 samples to lab

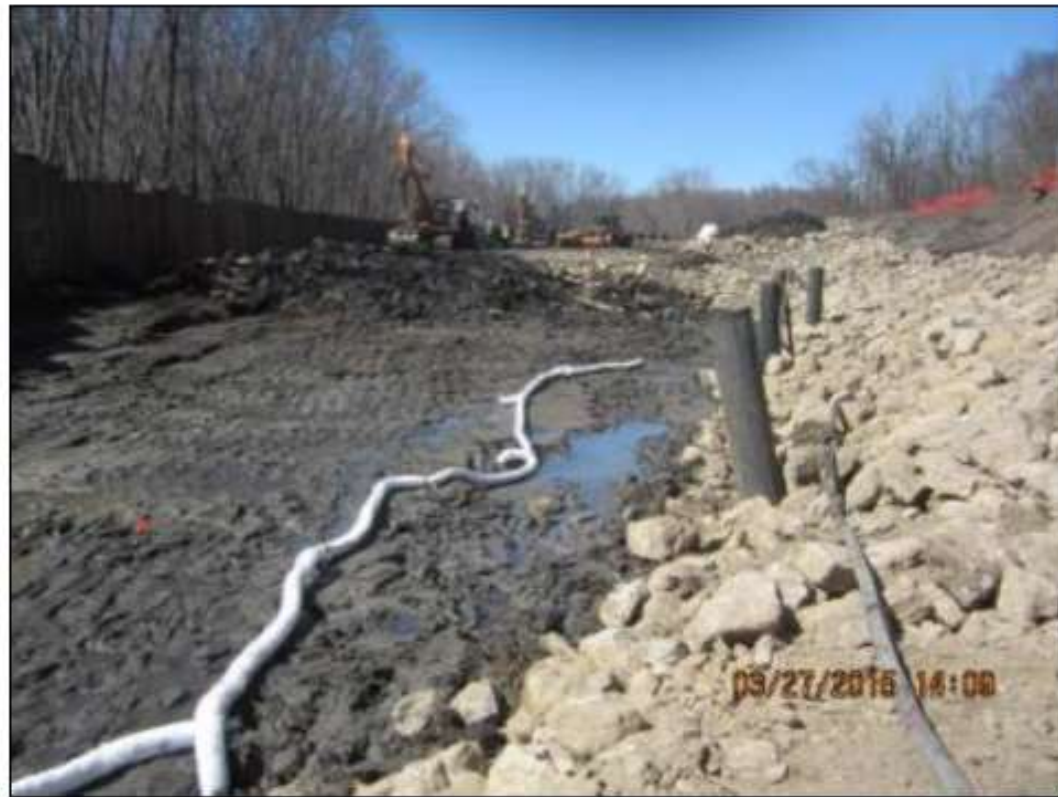
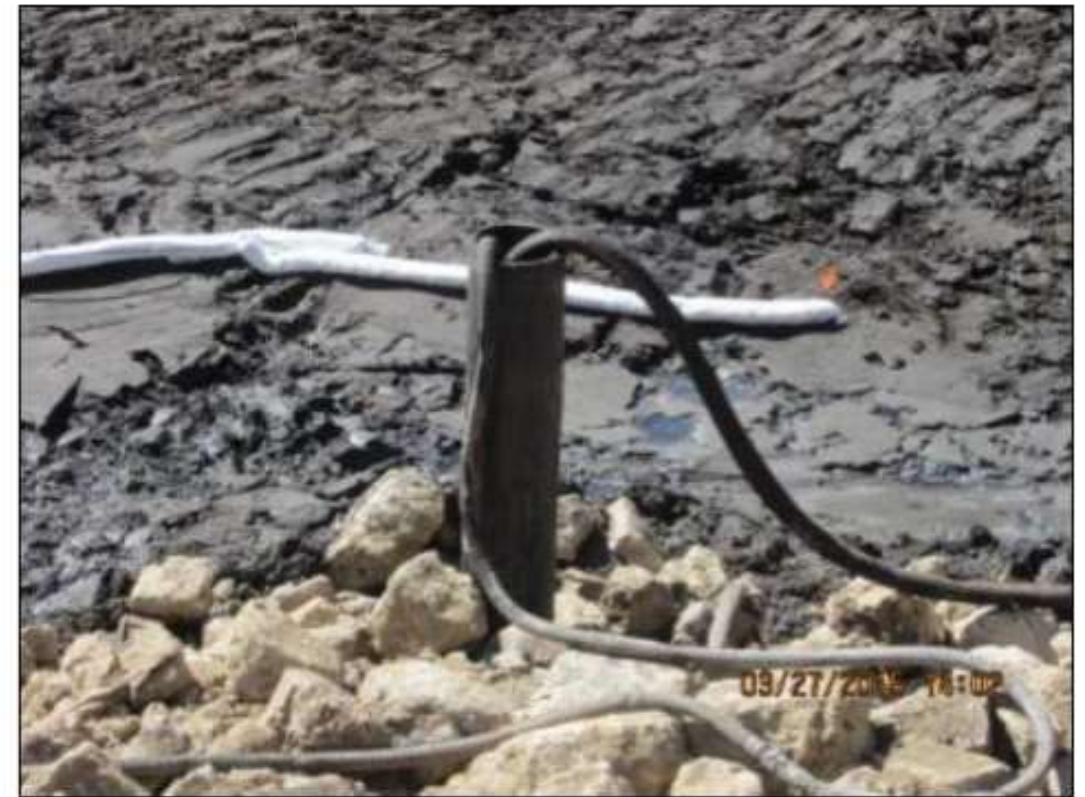
Metrics

Product	Total
Crude Oil (recovered)	221,421 gal
Contact Water (treated)	1,700,000 gal (+)
Contaminated Soil	4,748 tons (+)
Tankers wrecked	12
